Technical Evaluation of the Gold King Mine Incident

San Juan County, Colorado

U.S. Department of the Interior
Bureau of Reclamation
Technical Service Center
Denver, Colorado

October 2015

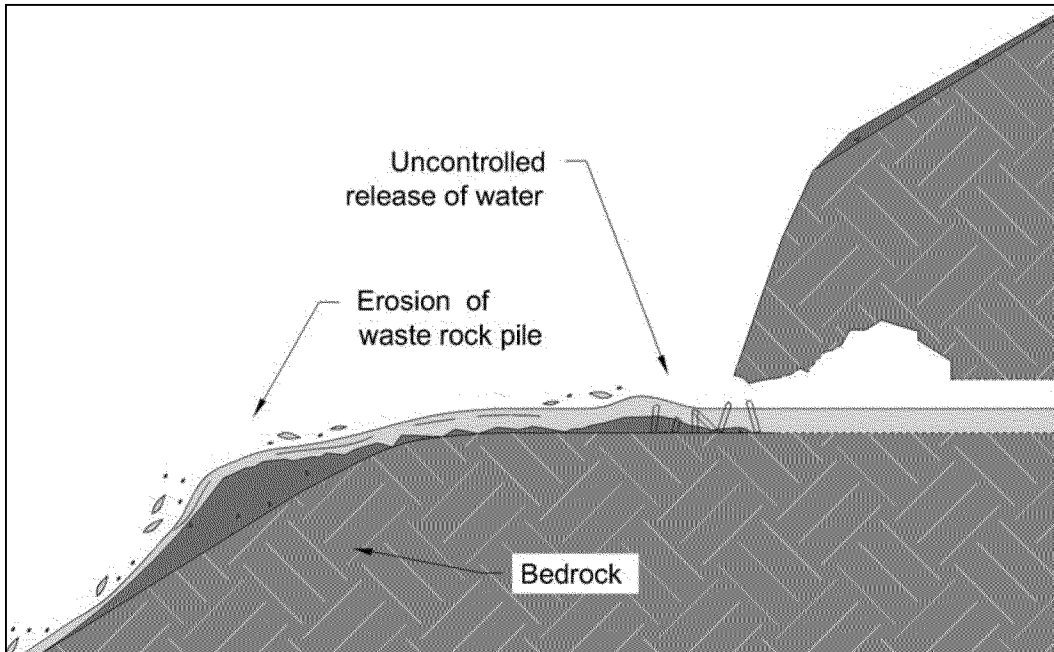
Figure 55.—Cross-section showing the blowout as it eroded the blockage and eroded fill from the waste-rock dump (not to scale).
